Second Five-Year Review Report  
for  
Raymark Industries, Inc. Site  
Stratford, Connecticut

September 2005

The United States Environmental Protection Agency  
Region 1, New England  
Boston, Massachusetts

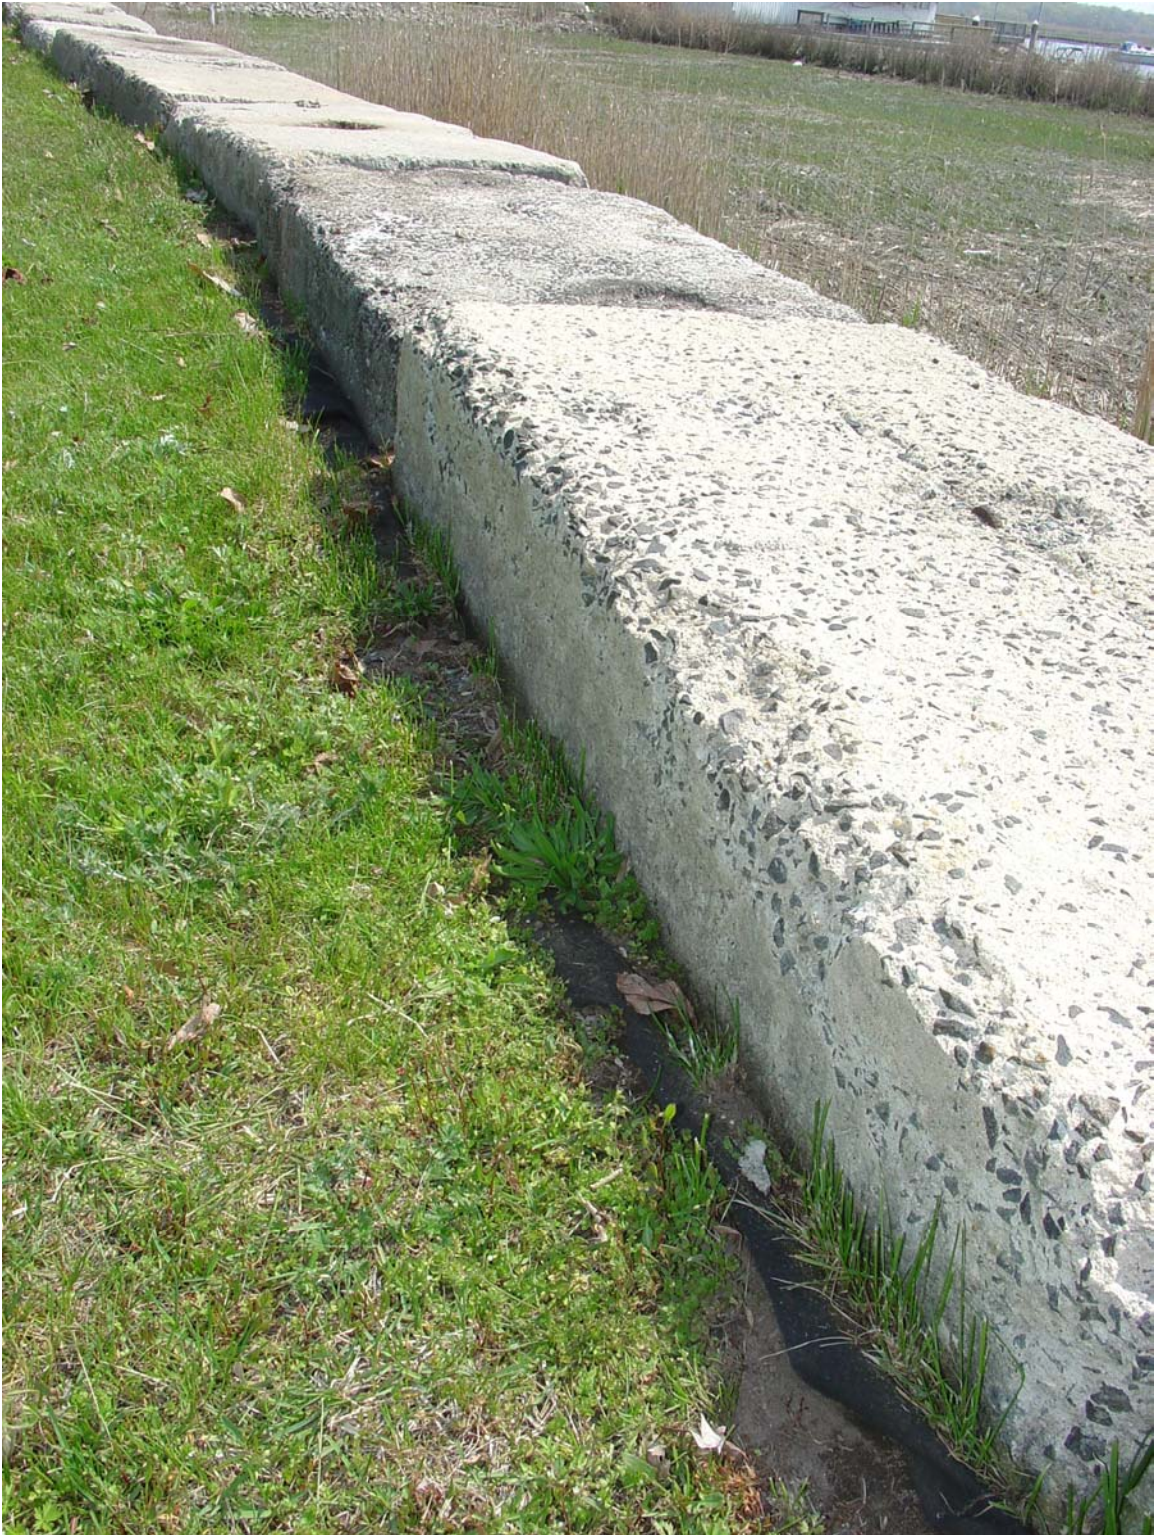
The geotextile was exposed in numerous areas where it meets the concrete block retaining wall.

1. Cracks in pavement should be sealed, especially along Shore Road.
2. Repair of monitoring well MW-532S and roadbox and monitoring well MW-530 should be made.
3. Geotextile repairs to the cover (south of the entrance to the boat club and along the concrete block retaining wall) and riprap repair (downstream of boat ramp structure) should be made.
4. Additional soil cover is needed for exposed areas south of the boat club entrance.
5. Settlement along the retaining wall and pavement should be regularly monitored for changes.

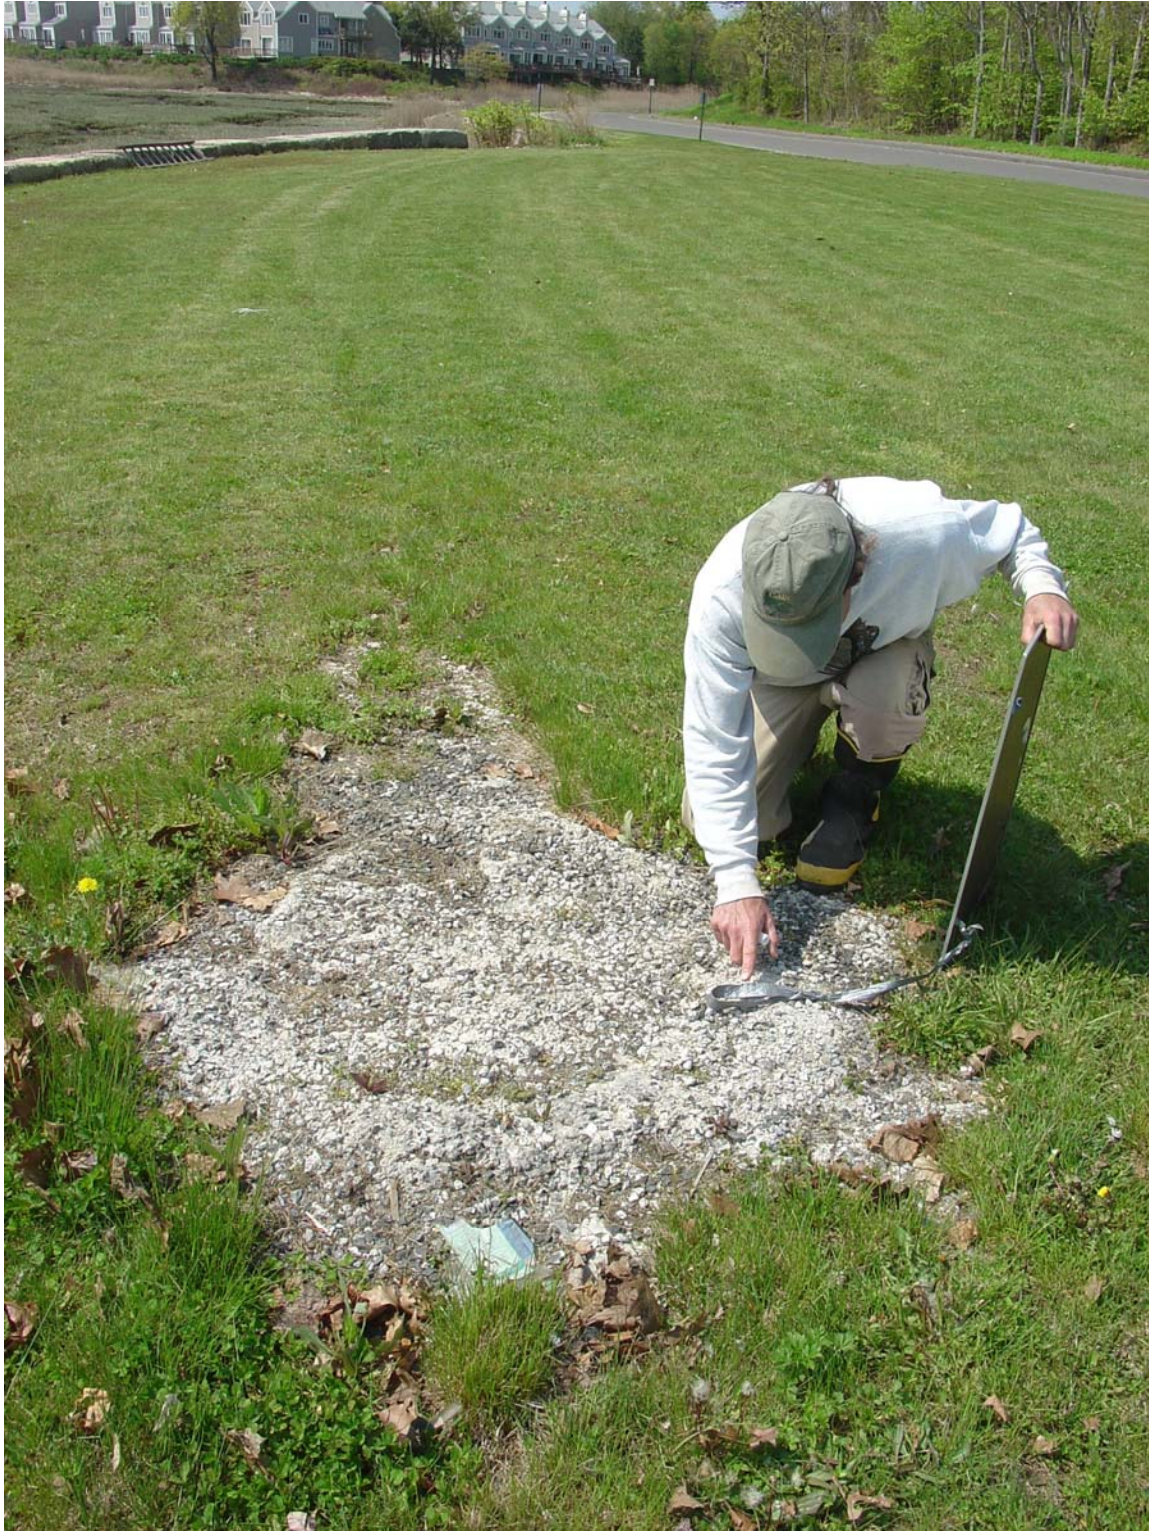
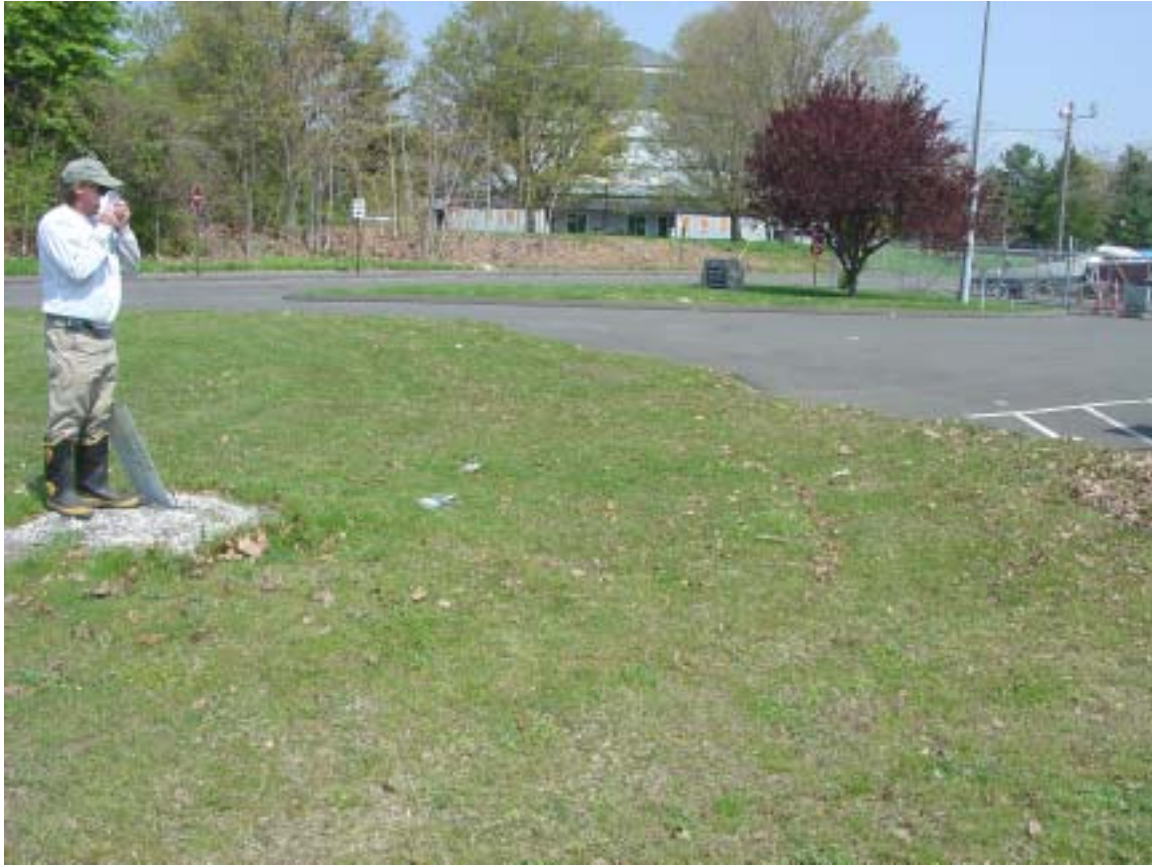
An area lacking topsoil appears to expose concrete or other fill in the same lawn immediately south of the boat club entrance. Next 2 photos.

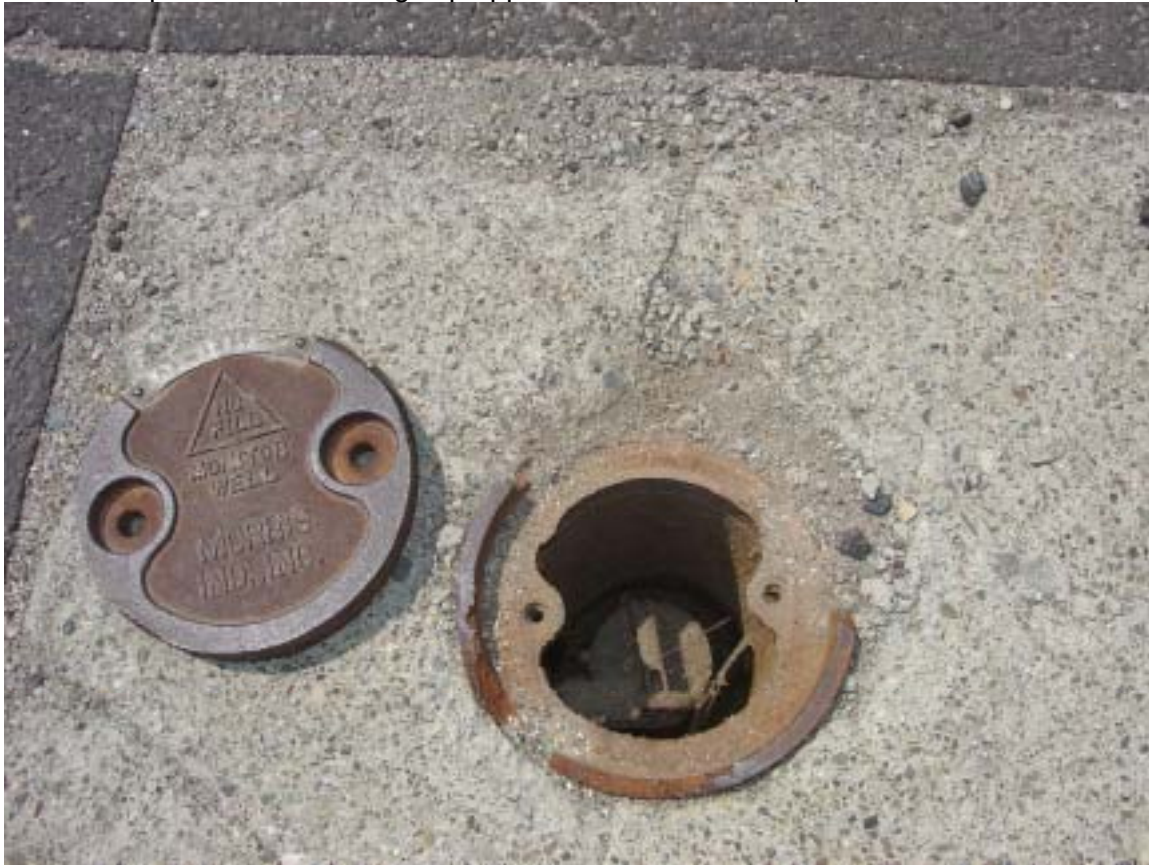
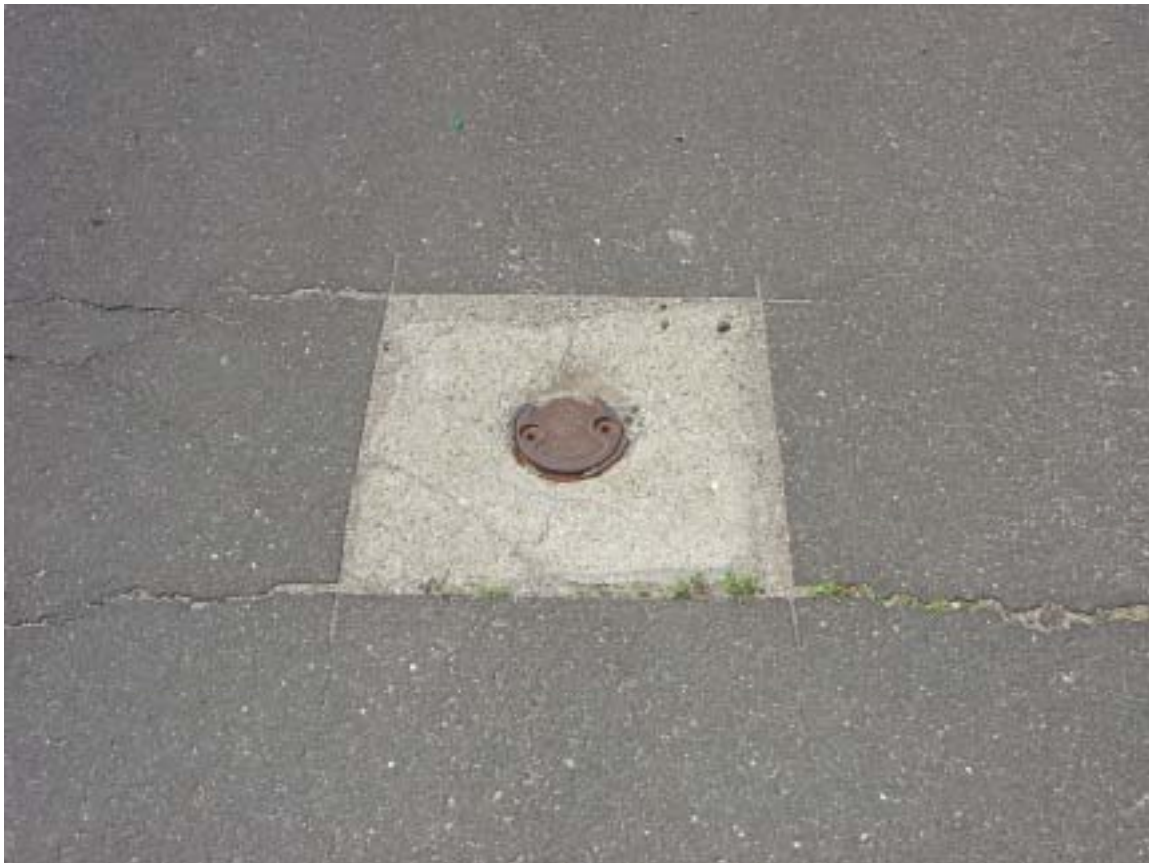
Monitoring well MW-532S in Shore Rd. was found with a broken road box id and missing lid bolts. The pvc well and locking cap appeared intact. Next 2 photos.

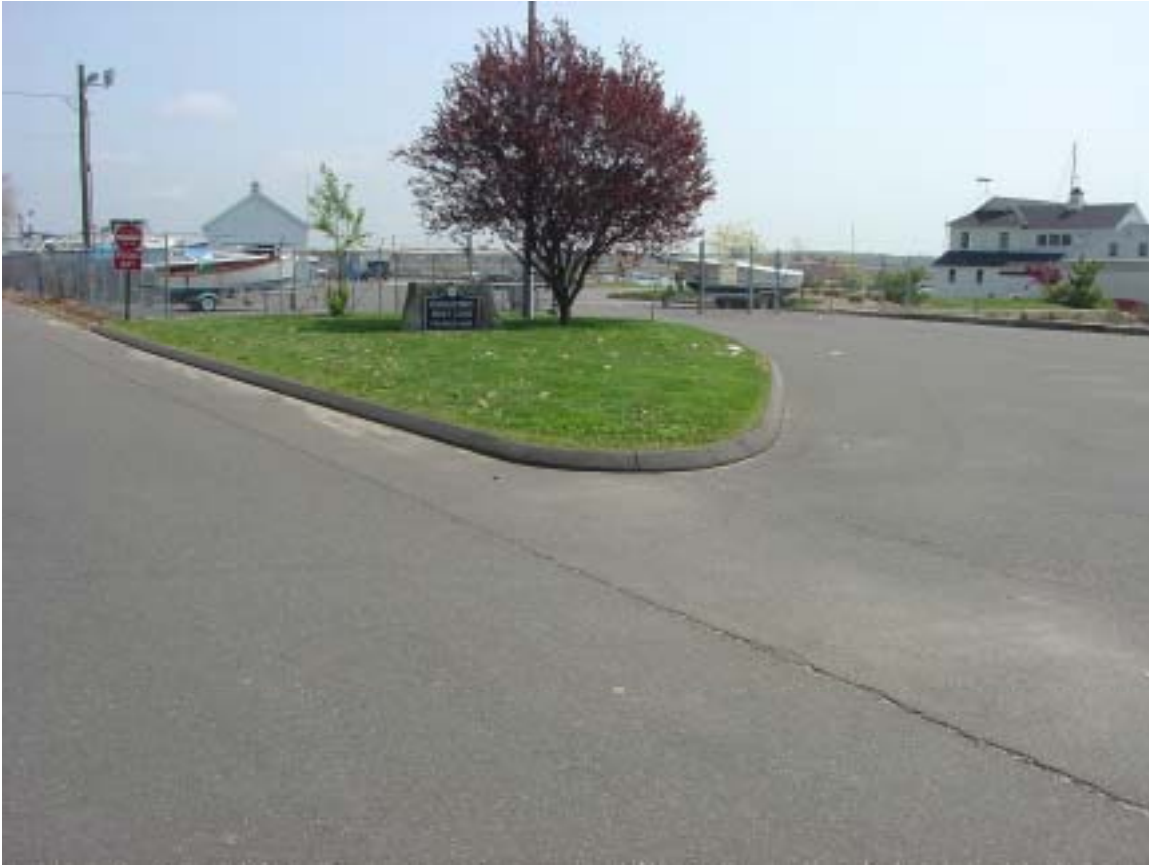
While some maintenance of the pavement has taken place inside the boat club property, the pavement on Shore Rd. itself is heavily cracked along seams with no sealer or patching evident.

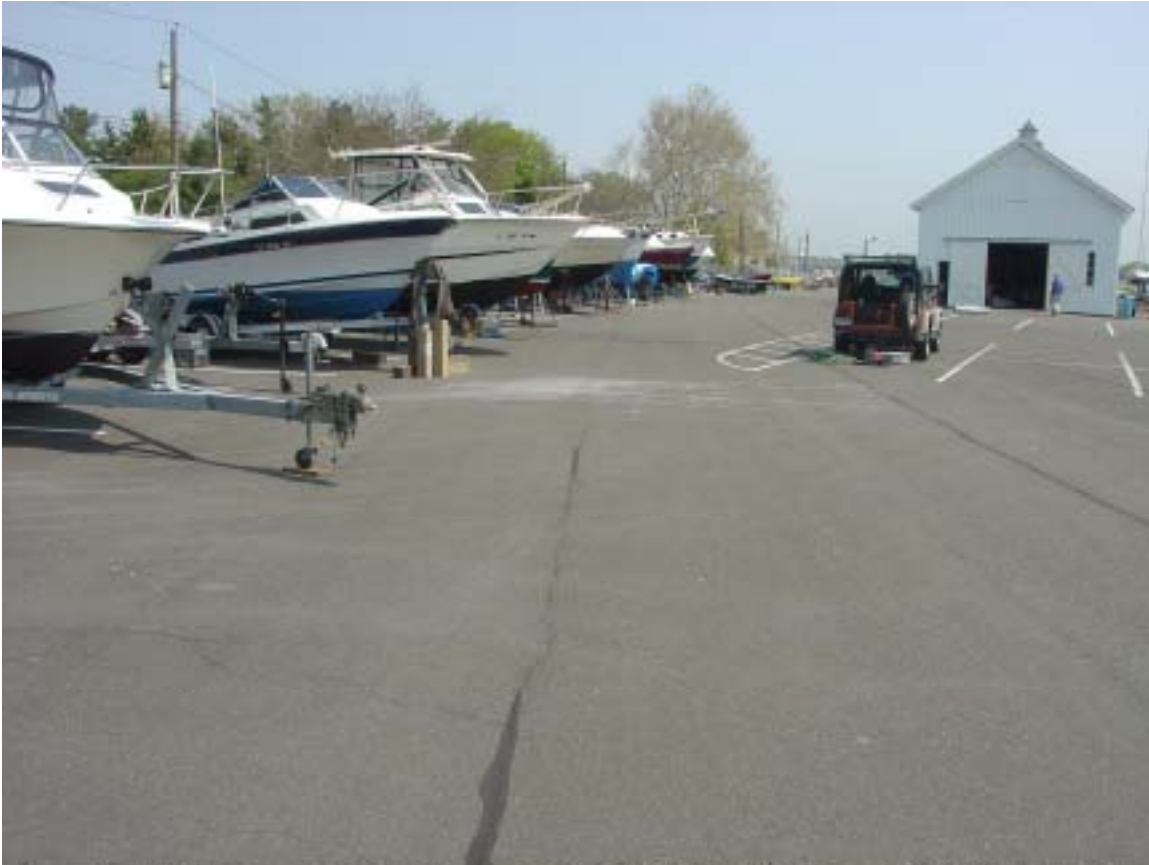
Photo of interior of Housatonic Boat Club property with previously cracked, sealed, and re-cracked pavement. The boat maintenance shed is on the right side of the photo.

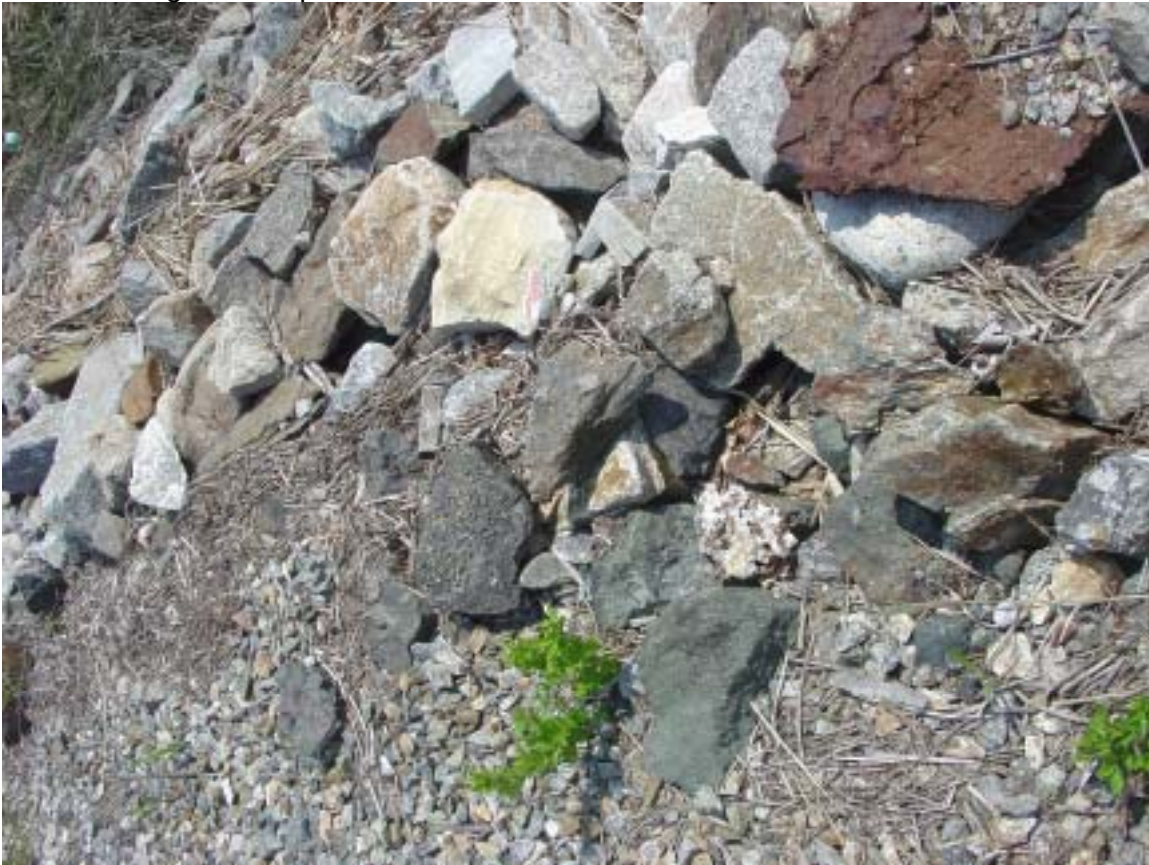
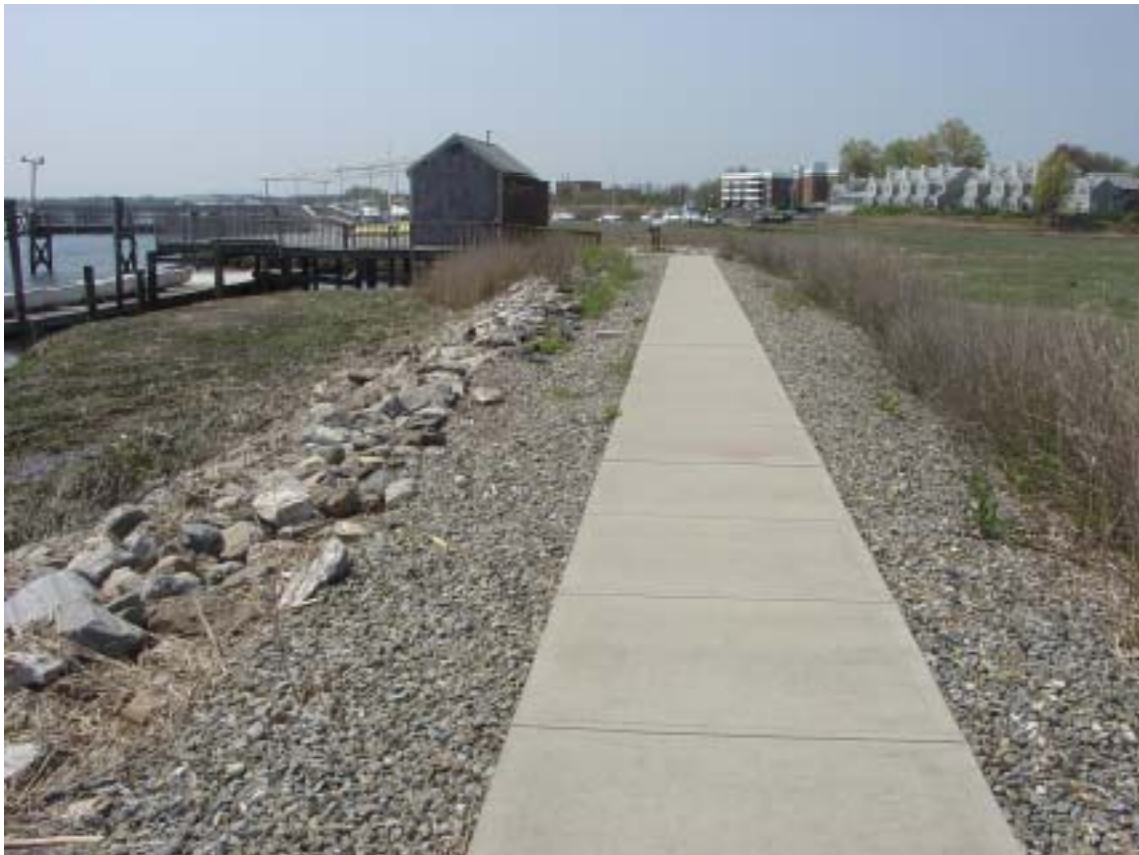
Steel slag and debris is easily noted within the rip-rap along the causeway south of the main boat club building. Next 2 photos.

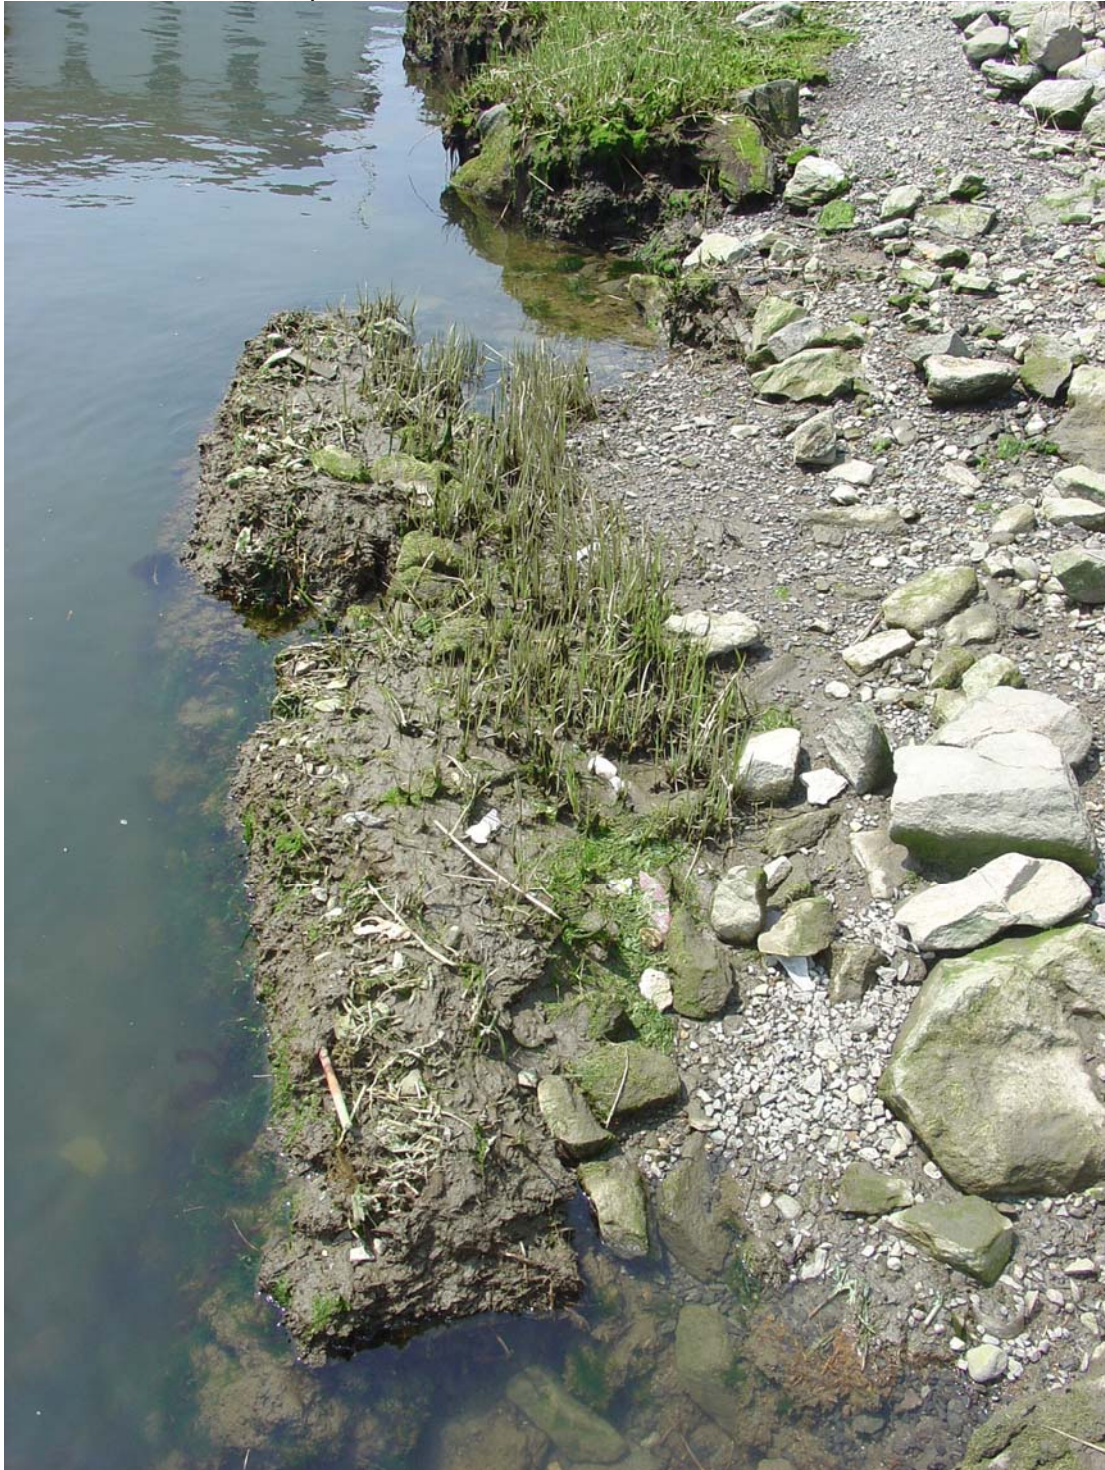
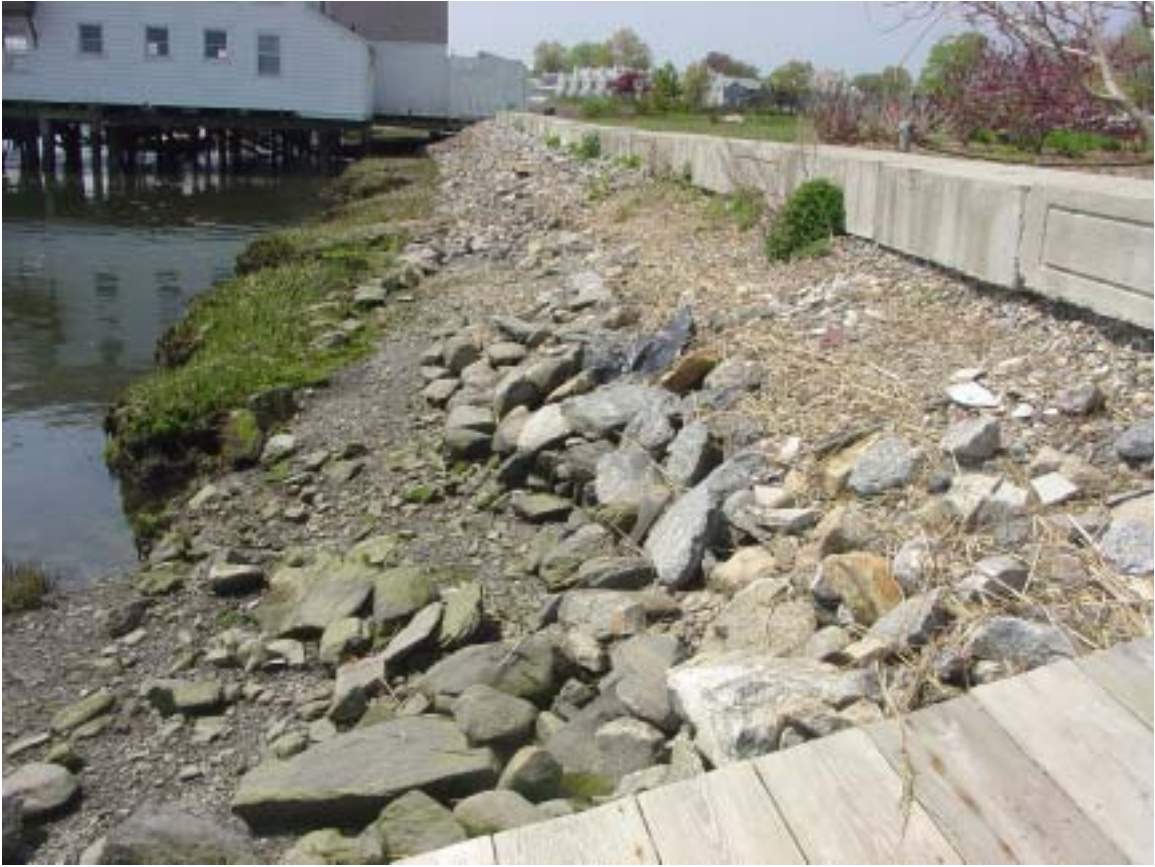
An area approx. 20 feet in length immediately south (downstream of the boat ramp structure) appears to have slumped/eroded into the river and may have allowed rip rap from above to fall into the river as well. Next 2 photos.

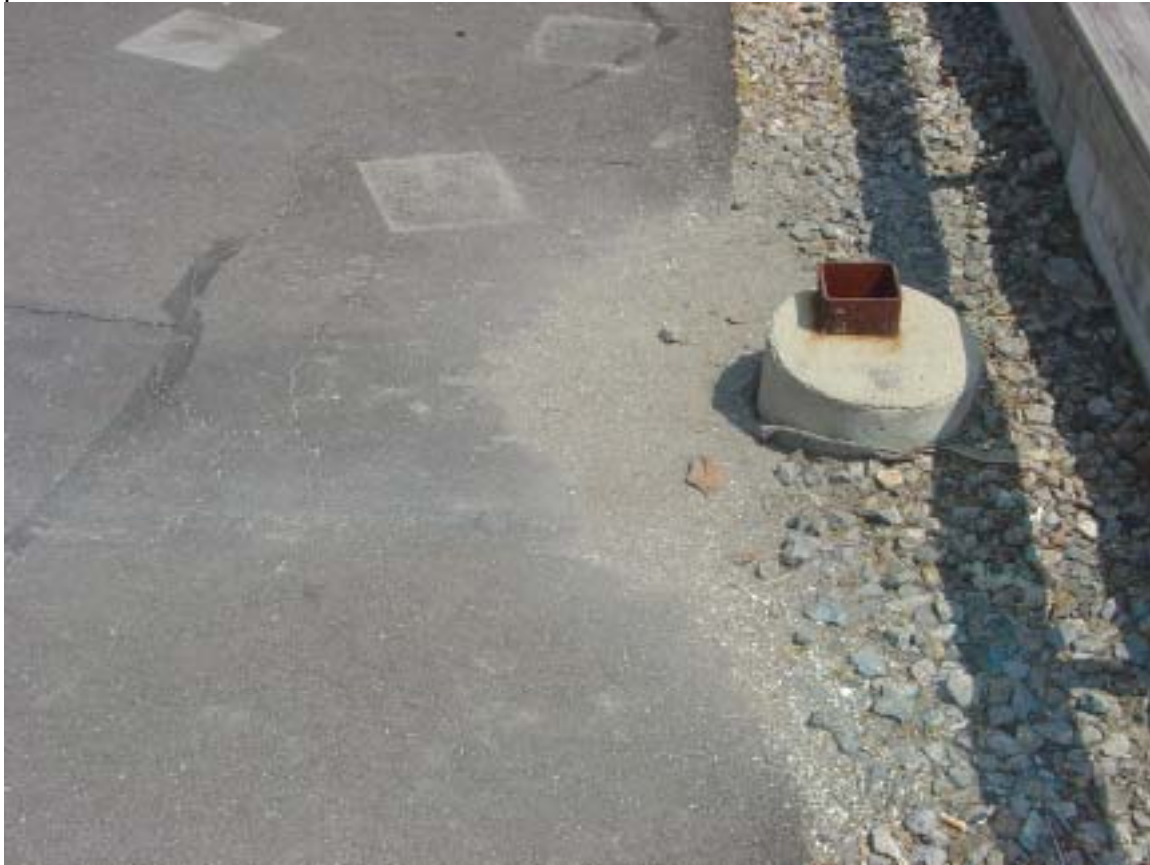
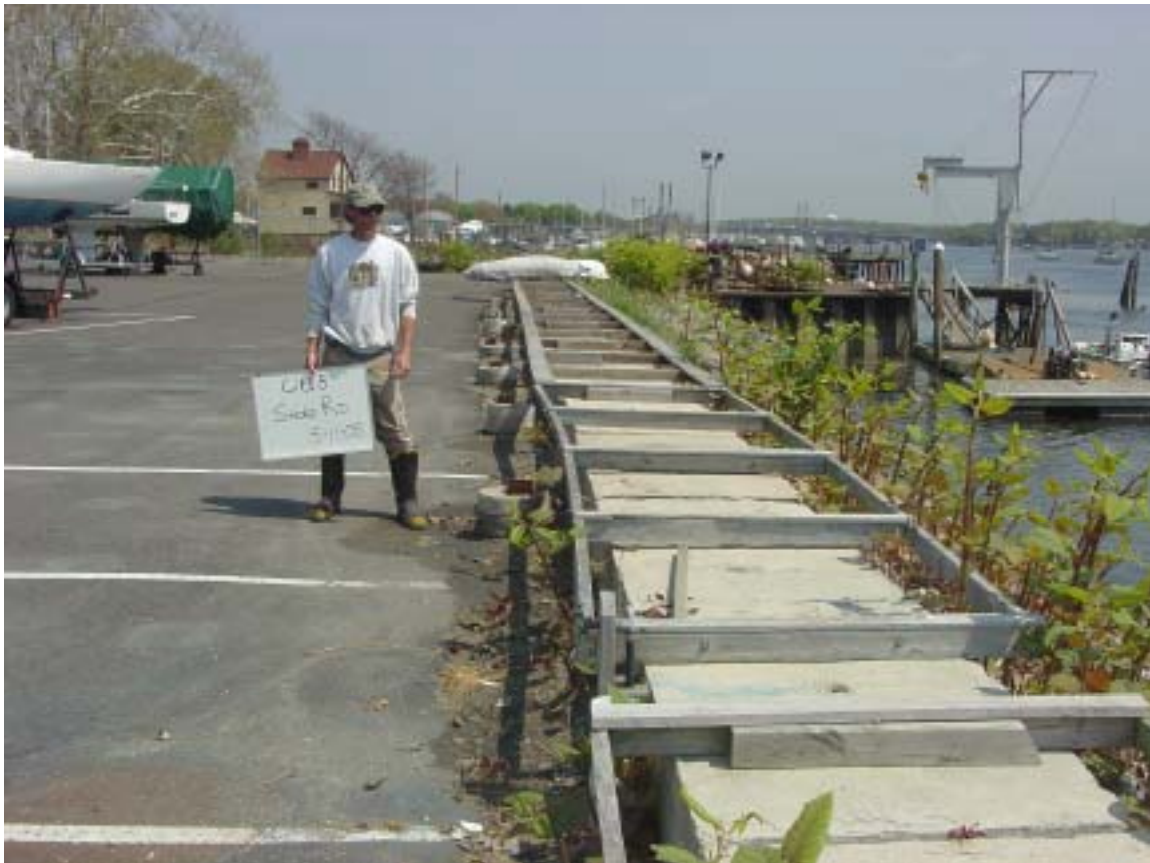
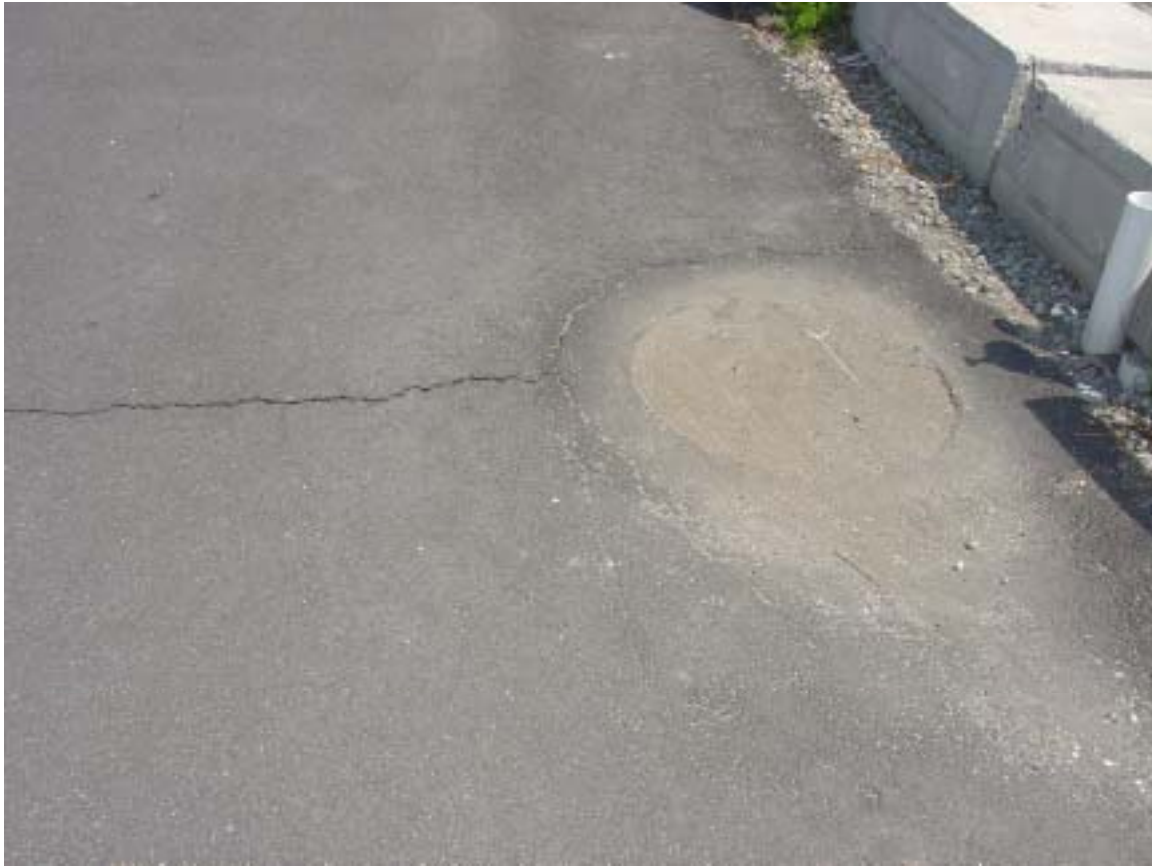
Areas along the edge of the pavement nearing the river show slight differential settling. Next 3 photos.

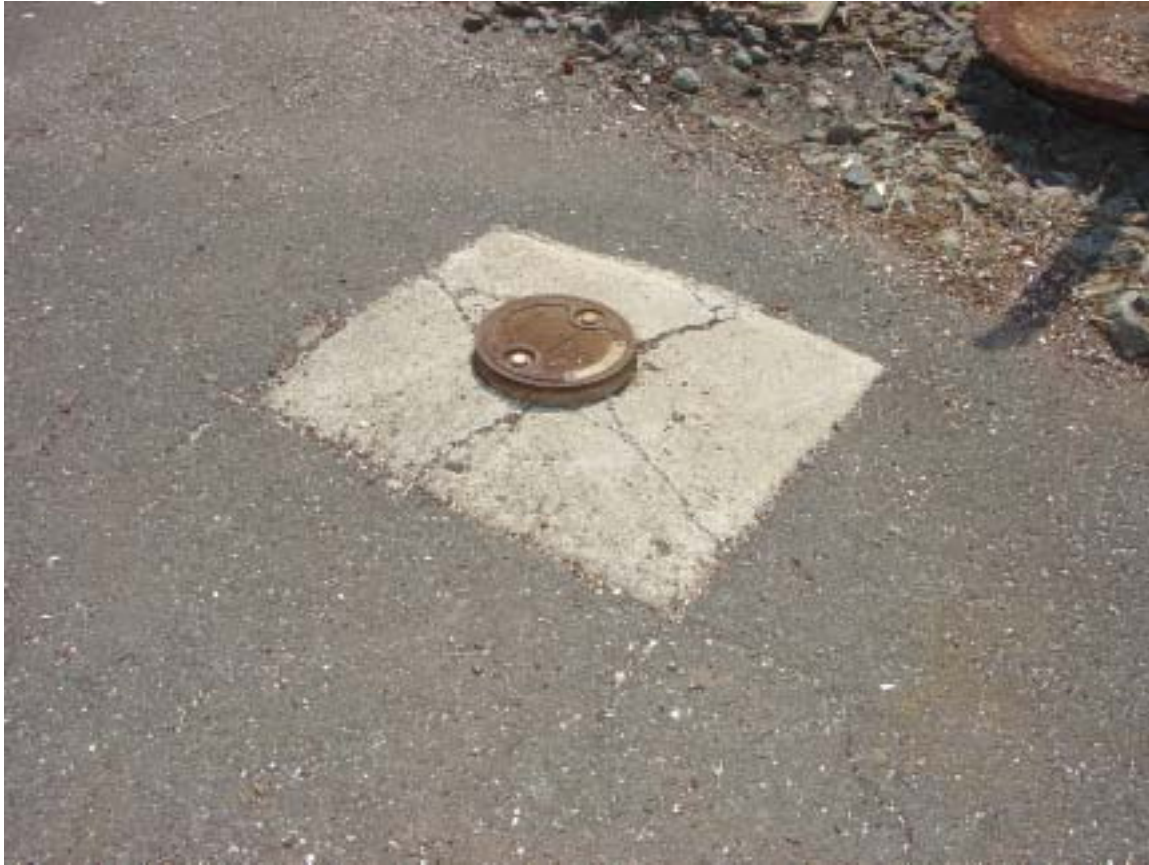
Monitoring well MW-530 near the sheet pile wall was found to have frost heave damage causing the road box to be heaved slightly above grade and cracking the surface seal.

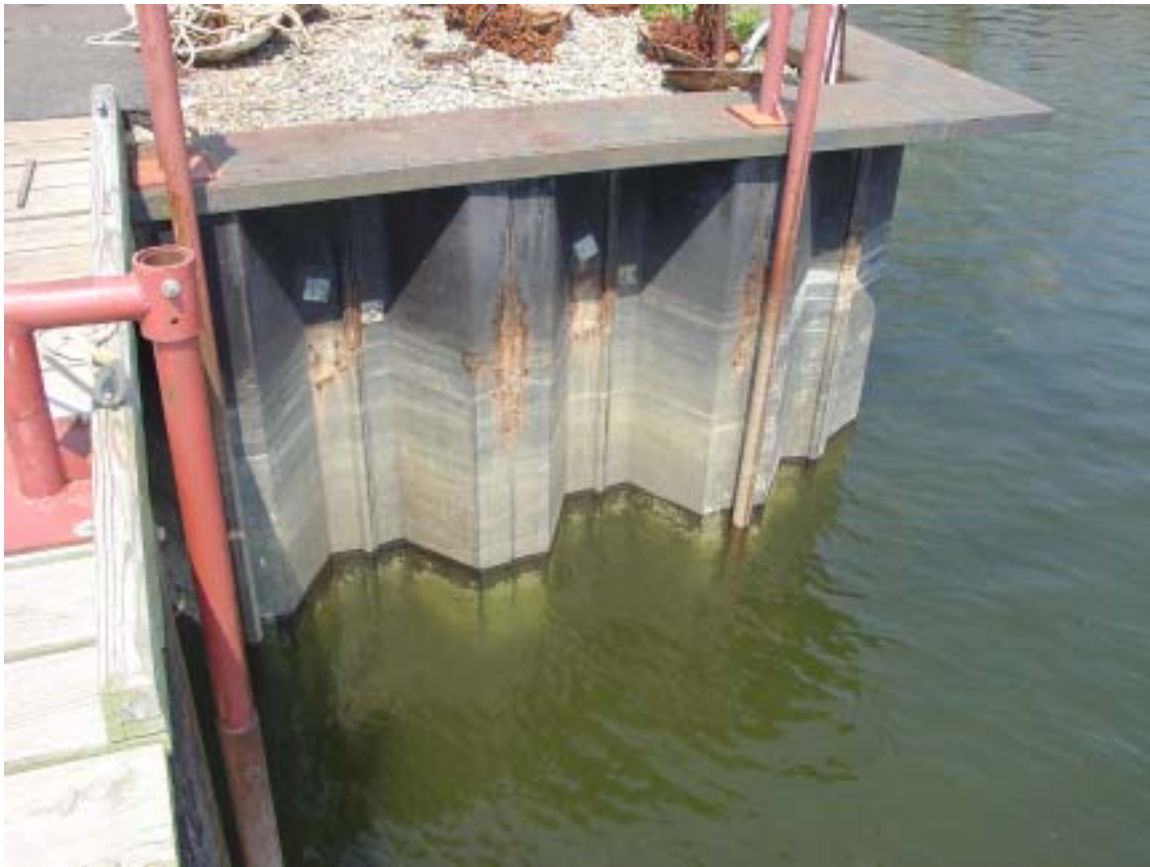
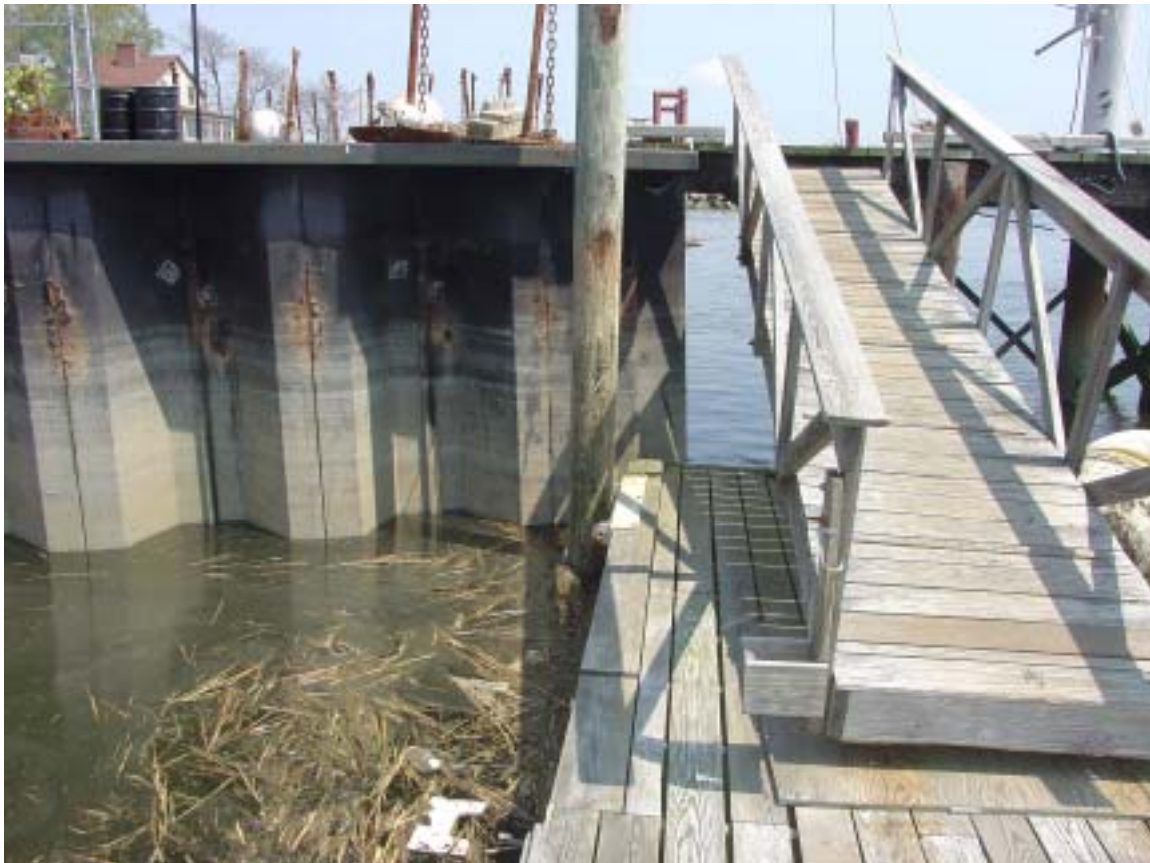
No issues were noted with the sheet pile walls other than typical wear and rust. Next 2 photos.

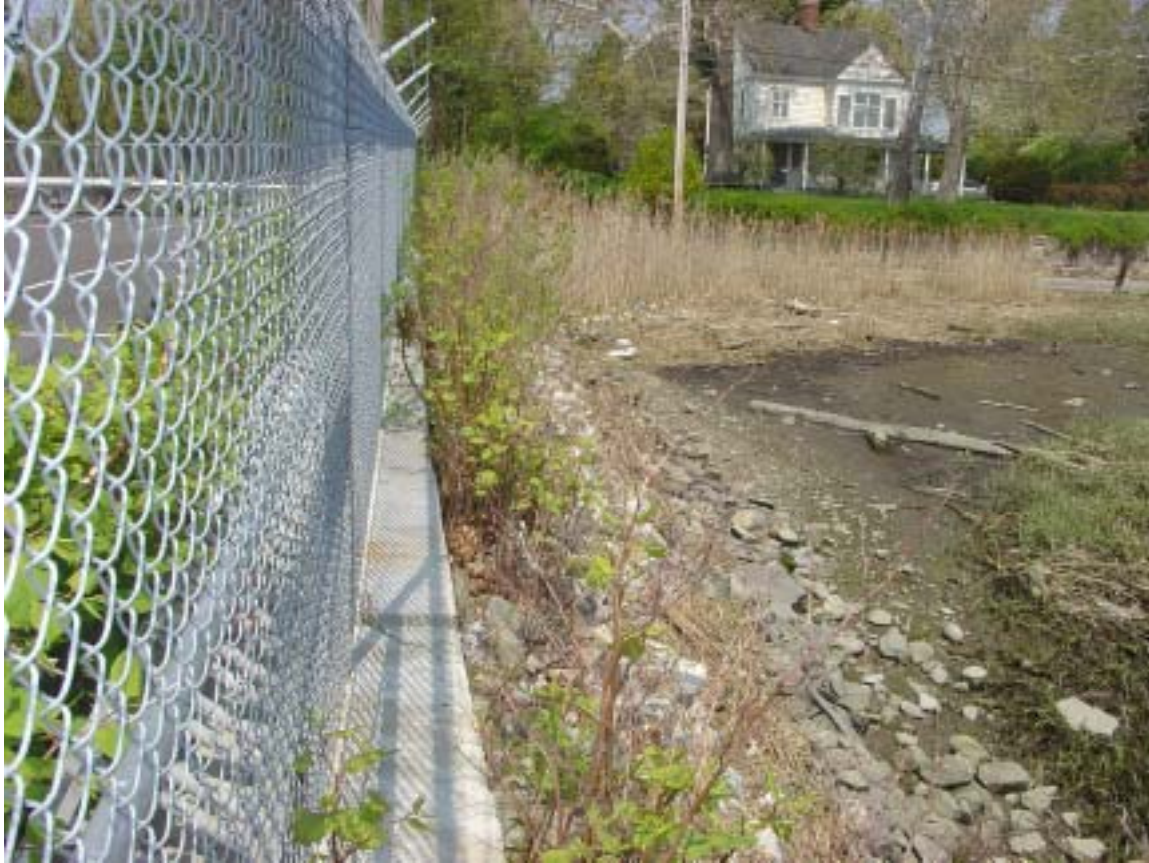
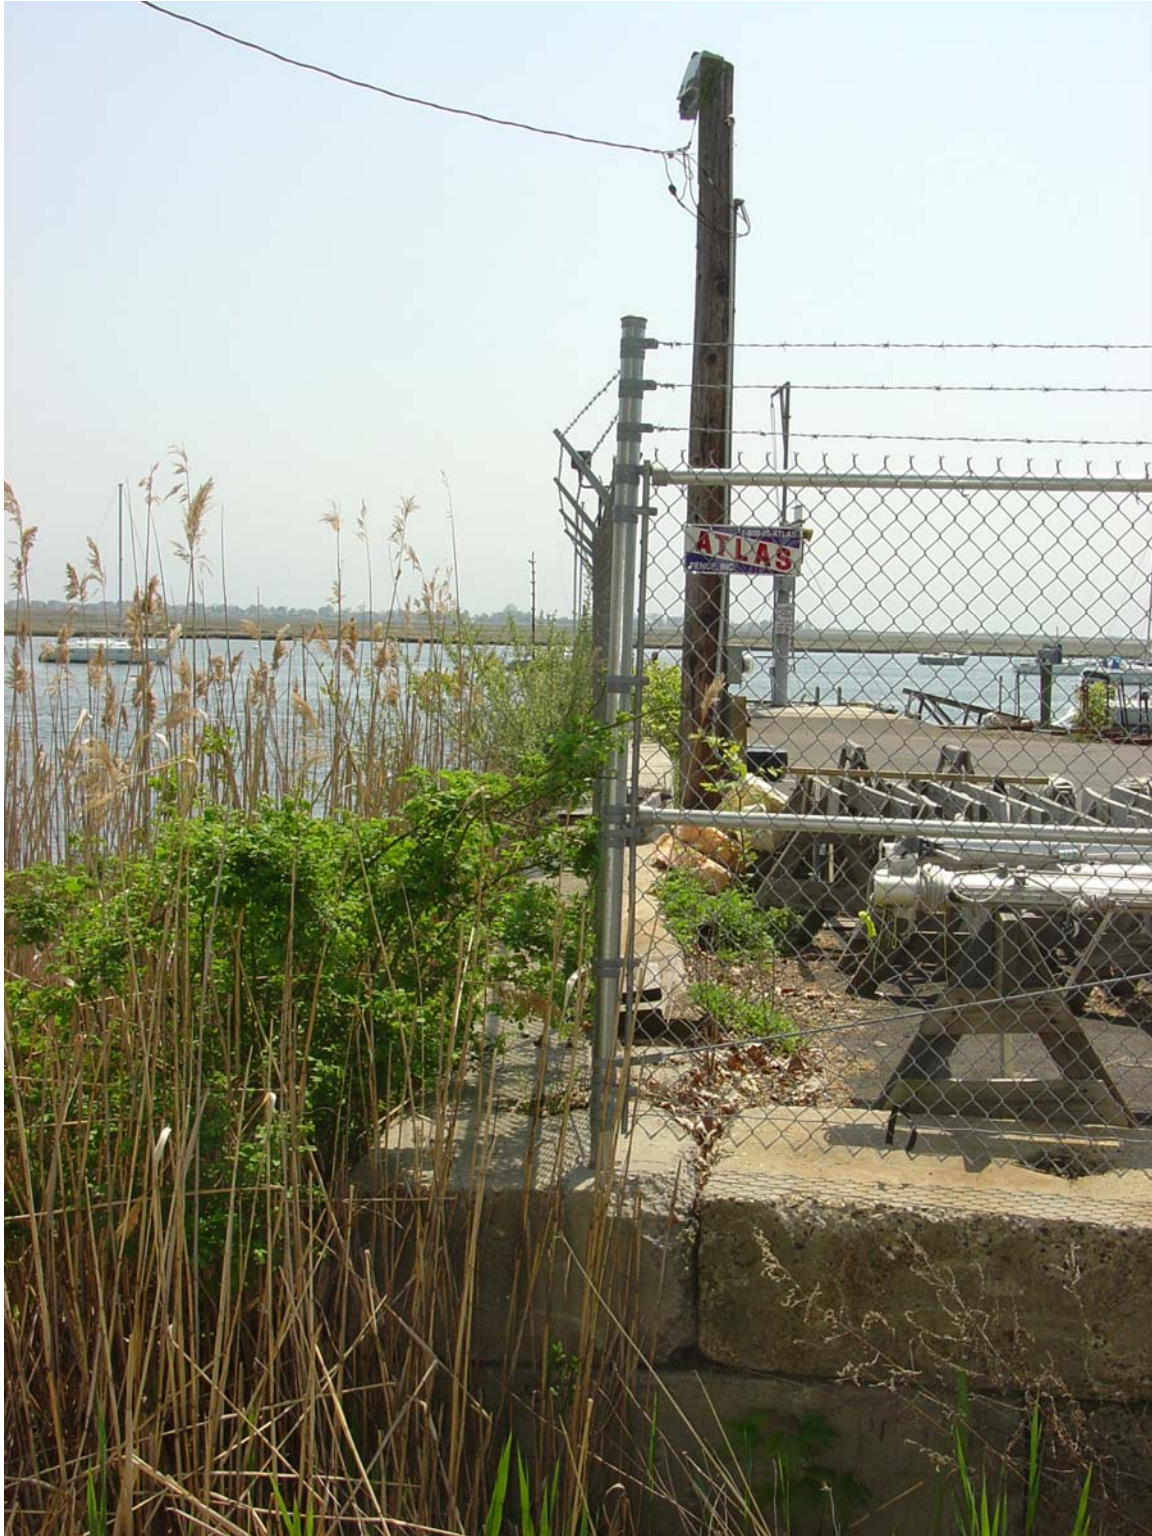
The northernmost retaining wall was difficult to observe due to heavy vegetation covering the fence and other physical obstructions. A possible slight bowing outward was visible by viewing the chain-link fence from end on. Next 2 photos.
